# Lake Ashton Community Development District

## Curblin and Pavement Assessment Report

November 17, 2020

PROJECT NAME: Lake Ashton CDD Pavement and Curb Assessment  
RES PROJECT #: 19-165

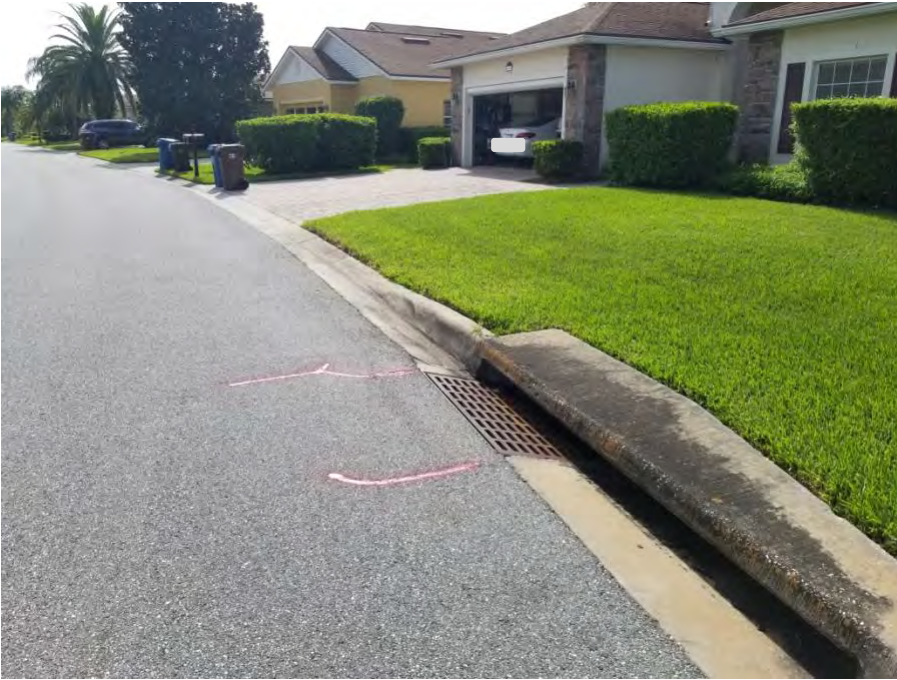
Exhibit 7B

| Defects | Address | Curbline | | | Pavement | Function | Exhibit |
|---|---|---|---|---|---|---|---|
| 117 | 4031 / 4035 Ashton Club Dr | - | - | | Reflective cracking present at manhole and inlet. | No | 6B, 7B |

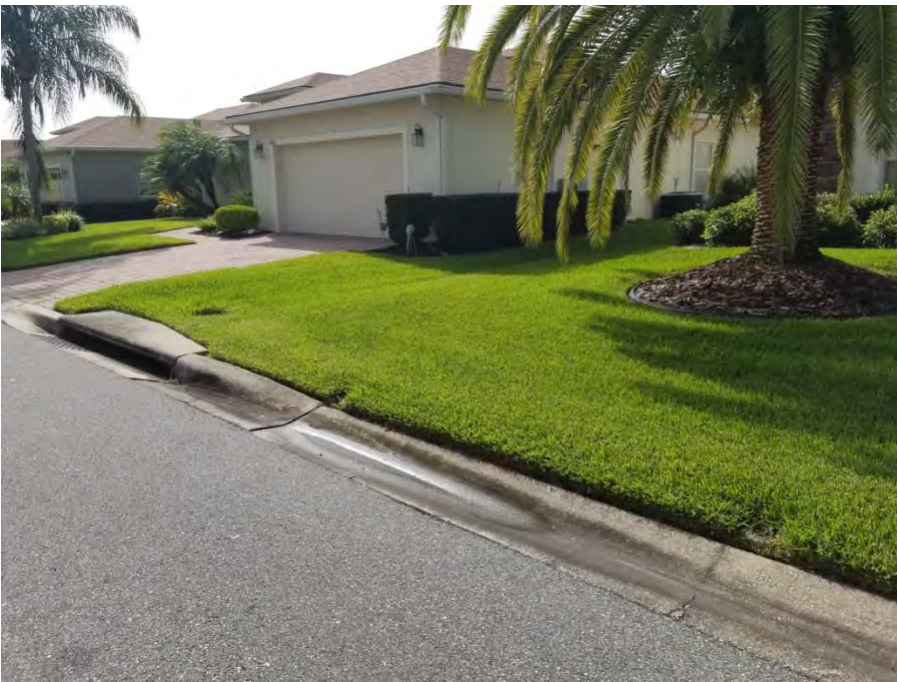
Exhibit 14B

| Defects | Address | Curbline | | | Pavement | Function | Exhibit |
|---|---|---|---|---|---|---|---|
| 124 | 4063 Ashton Club Dr | No | Yes | Curb sunken below lip of structure. | Reflective cracking present. | Yes | 14B, 15B, 16B |

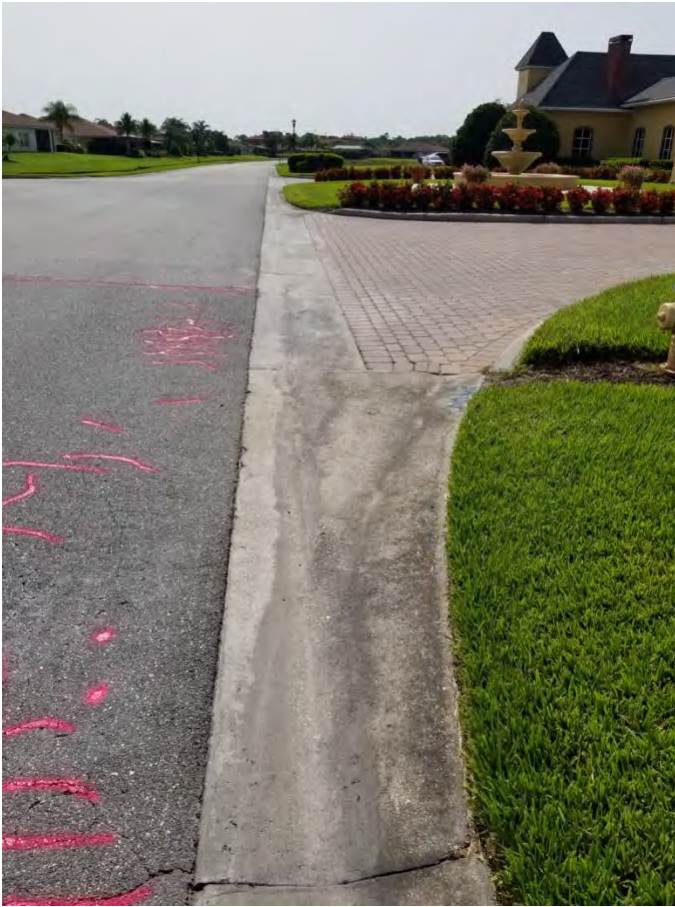
Exhibit 39B

| Defects | Address | Curbline | | | Pavement | Function Impaired | Exhibit |
|---|---|---|---|---|---|---|---|
| 141 | Circle Entrance at HFC | - | - | Valley gutter in poor condition. | Pavement broken and patched. | Yes | 39B |

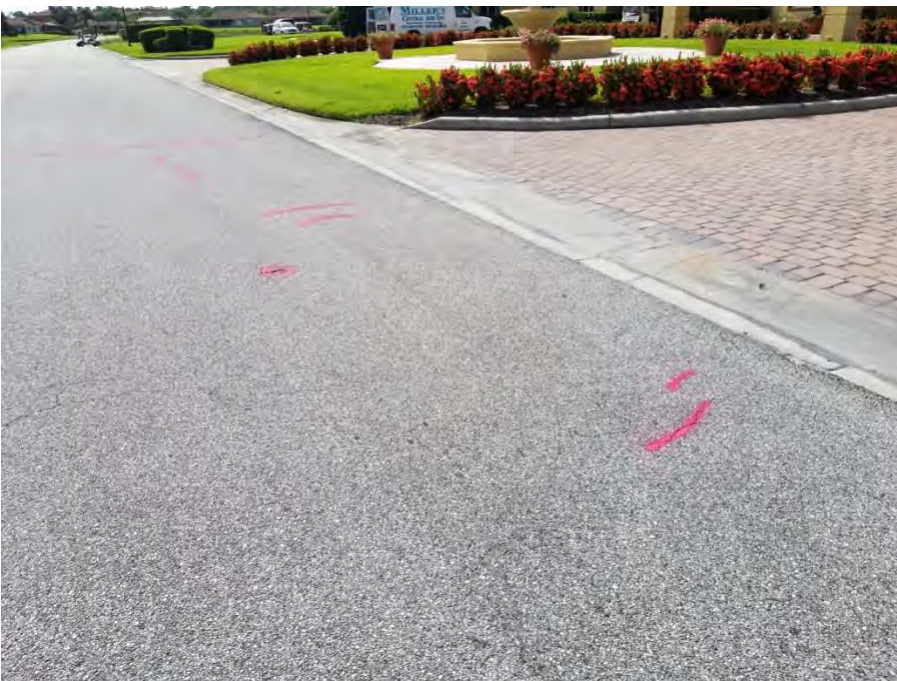
Exhibit 40B

| Defects | Address | Curbline | | | Pavement | Function Impaired | Exhibit |
|---|---|---|---|---|---|---|---|
| 142 | Fountain at HFC- | - | - | | Gouges present. Transverse and longitudinal cracking present. | No | 40B |

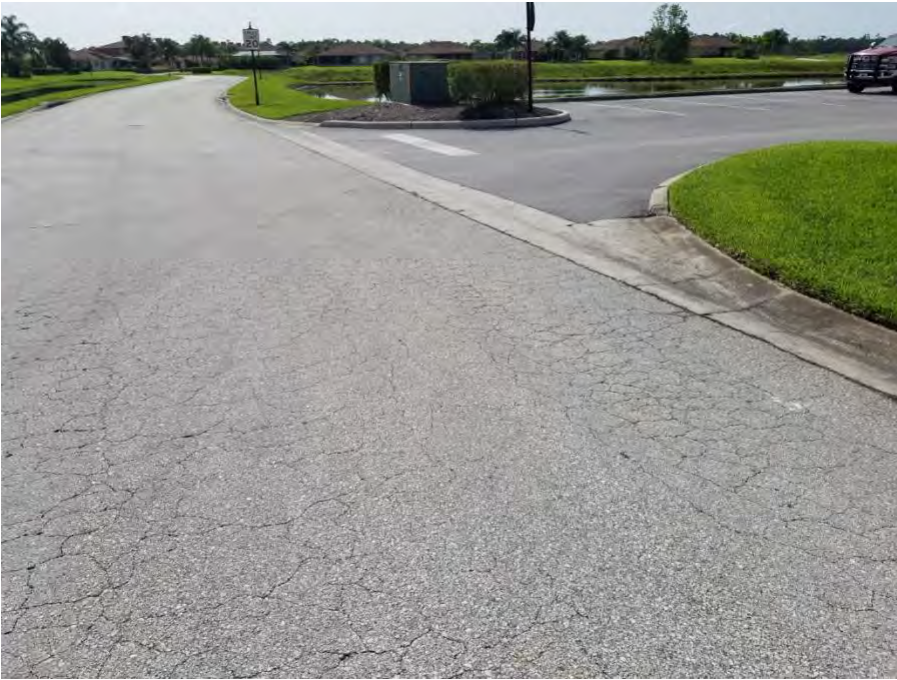
Exhibit 45B

| Defects | Address | Curbline | | | Pavement | Function Impaired | Exhibit |
|---|---|---|---|---|---|---|---|
| 146 | At side parking lot entrance at HFC | Yes | No | | Full lane width alligator cracking present. | Yes | 45B |

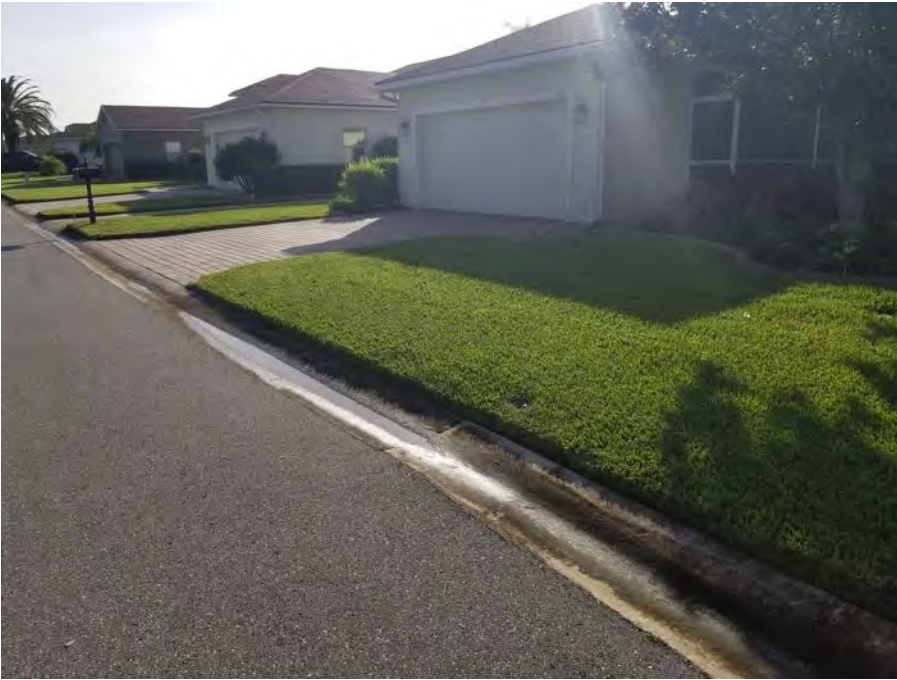
Exhibit 9C

| Defects | Address | Curbline | | | Pavement | Function Impaired | Exhibit |
|---|---|---|---|---|---|---|---|
| 154 | 4271 Ashton Club Drive | No | Yes | Sunken curb present at previous repair location. | | No | 9C |

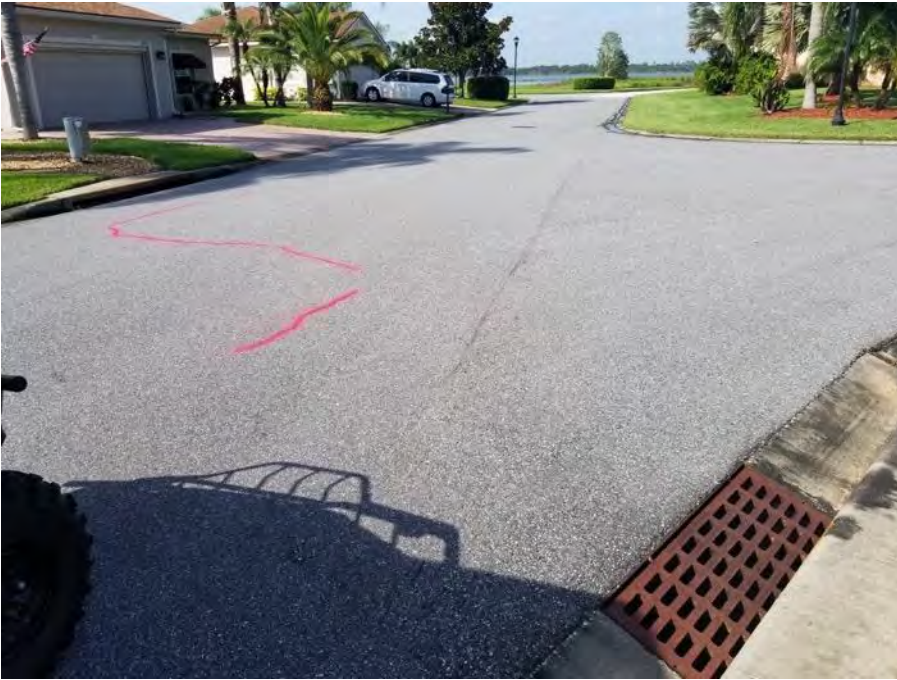
Exhibit 29C

| Defects | Address | Curbline | | | Pavement | Function Impaired | Exhibit |
|---|---|---|---|---|---|---|---|
| 173 | Opposite 4255 Ashton Club Drive | - | - | | Longitudinal and transverse cracking likely due to settlement over a storm pipe. | Yes | 29C |

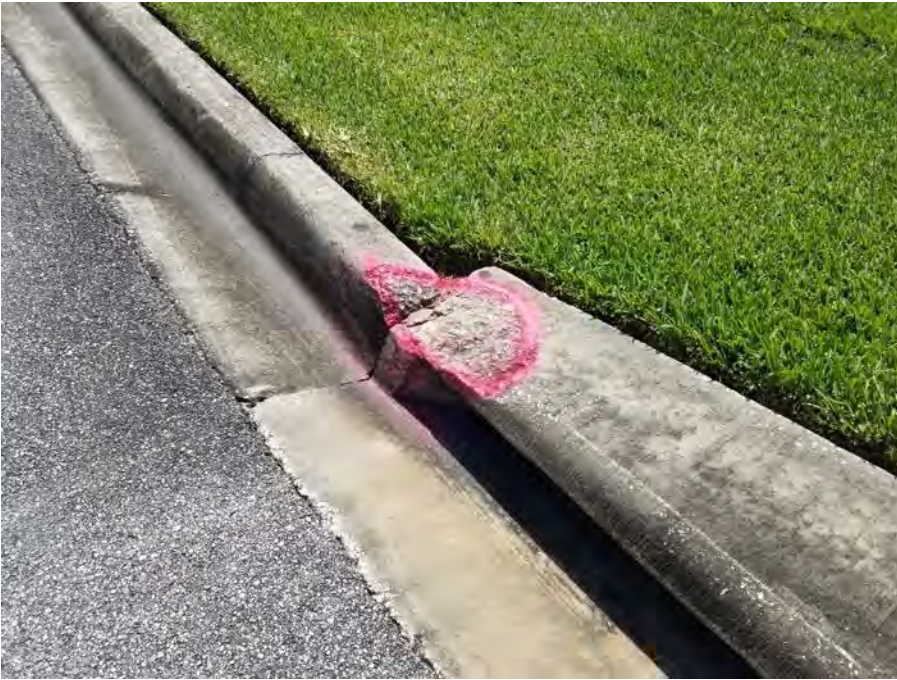
Exhibit 73C

| Defects | Address | Curbline | | | Pavement | Function Impaired | Exhibit |
|---|---|---|---|---|---|---|---|
| 211 | Lake Ashton Blvd Outbound | Yes | - | Broken inlet top. | | No | 73C |

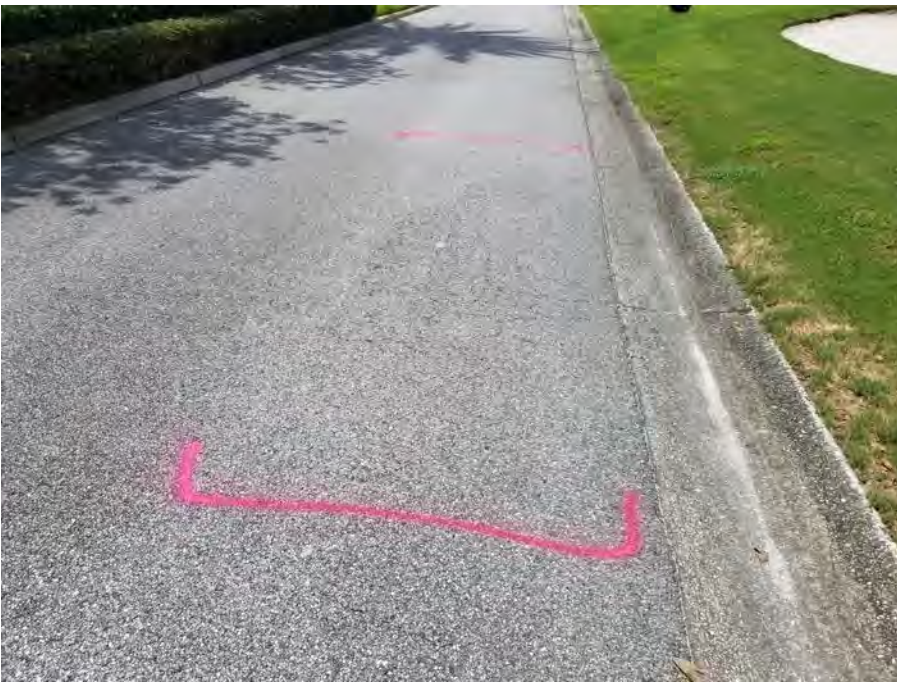
Exhibit 93C

| Defects | Address | Curbline | | | Pavement | Function Impaired | Exhibit |
|---|---|---|---|---|---|---|---|
| 228 | Approximately 1,231 ± feet South of Guard Shack | - | - | | 20 feet of alligator cracking present | No | 93C |

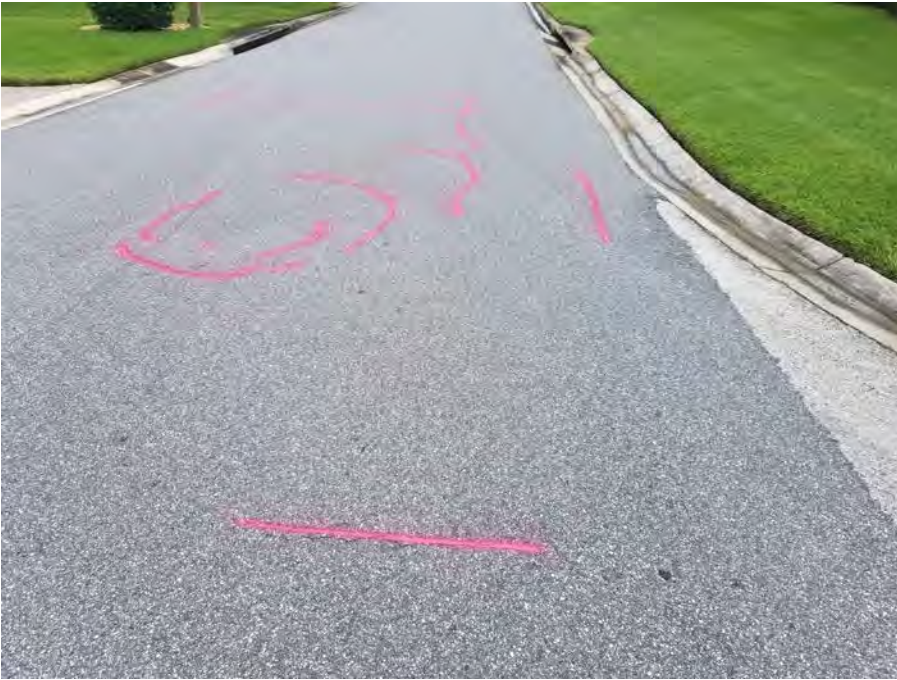
Exhibit 106C

| Defects | Address | Curbline | | | Pavement | Function Impaired | Exhibit |
|---|---|---|---|---|---|---|---|
| 241 | Opposite 2206 / 2106 Ashton Palms Drive | No | Yes | | Sunken pavement present in roadway center line; Longitudinal and transverse cracking present. | Yes | 106C |

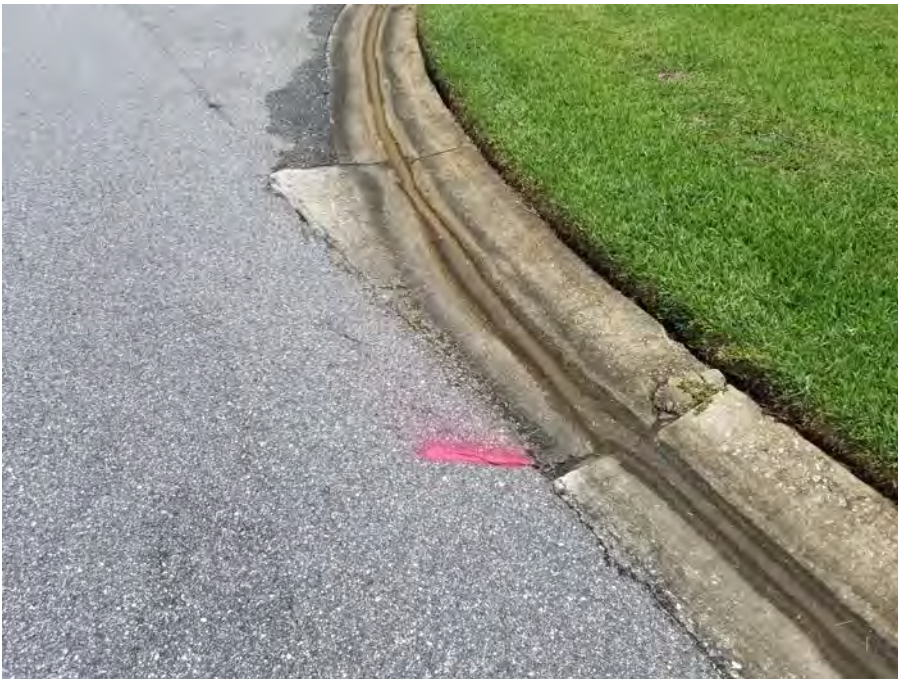
Exhibit 113C

| Defects | Address | Curbline | | | Pavement | Function Impaired | Exhibit |
|---|---|---|---|---|---|---|---|
| 248 | Opposite 3022 Ashton Palms Drive | Yes | Yes | | Cracking in pavement present. | No | 113C |

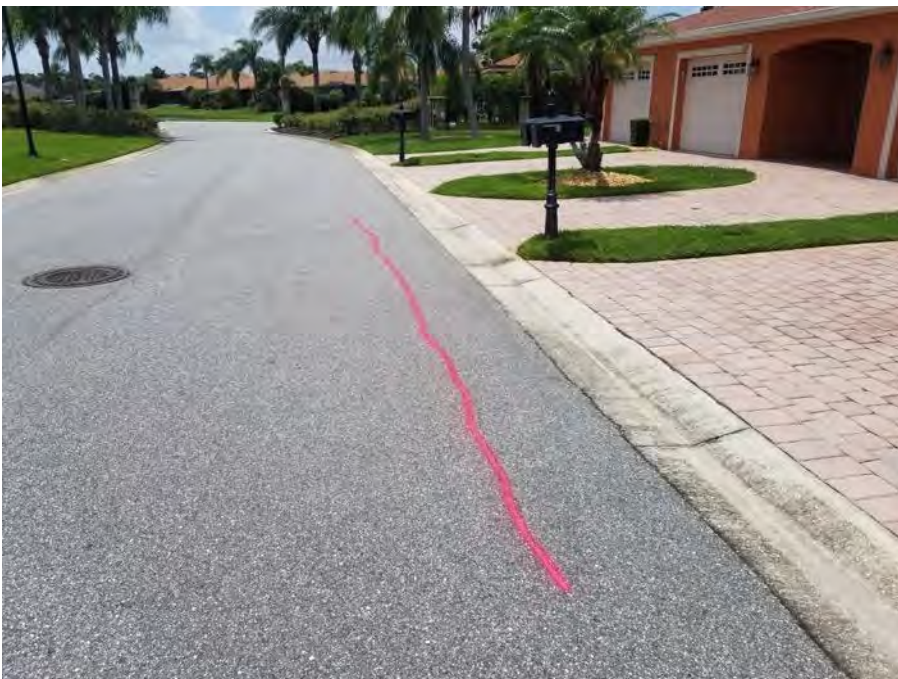
Exhibit 121C

| Defects | Address | Curbline | | | Pavement | Function Impaired | Exhibit |
|---|---|---|---|---|---|---|---|
| 255 | 1202 Ashton Palms Drive | - | - | | Longitudinal cracking present. | No | 121C |

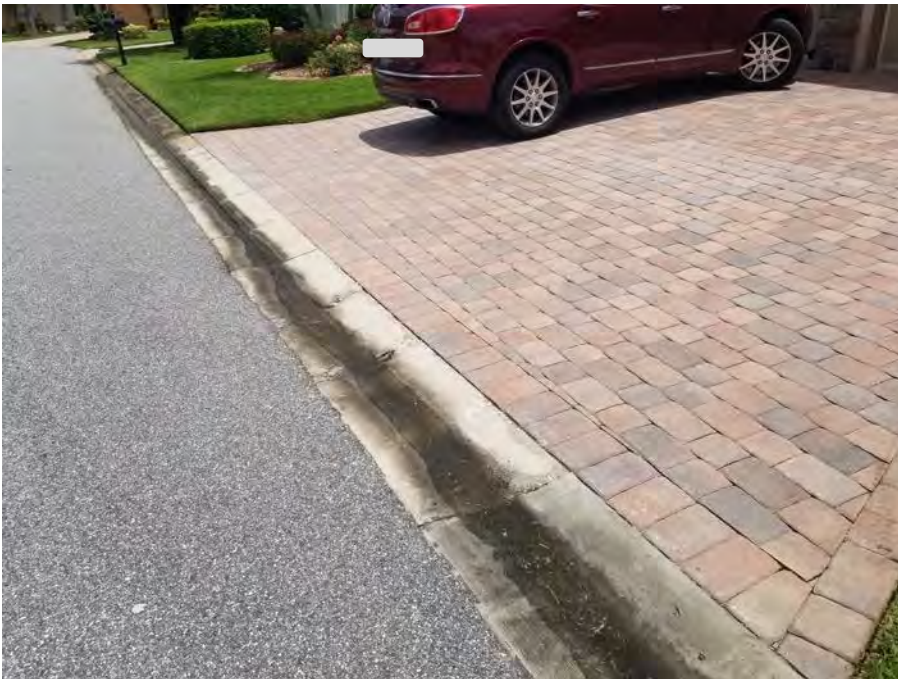
Exhibit 131C

| Defects | Address | Curbline | | | Pavement | Function Impaired | Exhibit |
|---|---|---|---|---|---|---|---|
| 263 | 4029 Ashton Palms Drive | Yes | - | High point present in curb on previous repair. Impaired on the East side. | Longitudinal and transverse cracking present. | Yes | 130C, 131C |

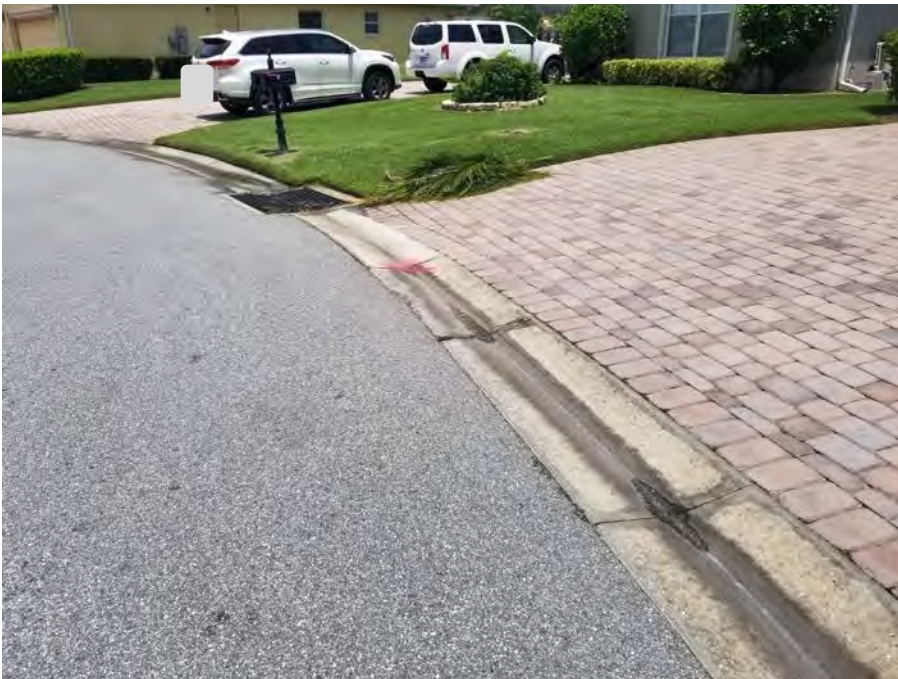
Exhibit 132C

| Defects | Address | Curbline | | | Pavement | Function Impaired | Exhibit |
|---|---|---|---|---|---|---|---|
| 264 | 4013 Ashton Palms Drive | - | - | High point present in curb on previous repair. Impaired on the East and West side. | | Yes | 132C |

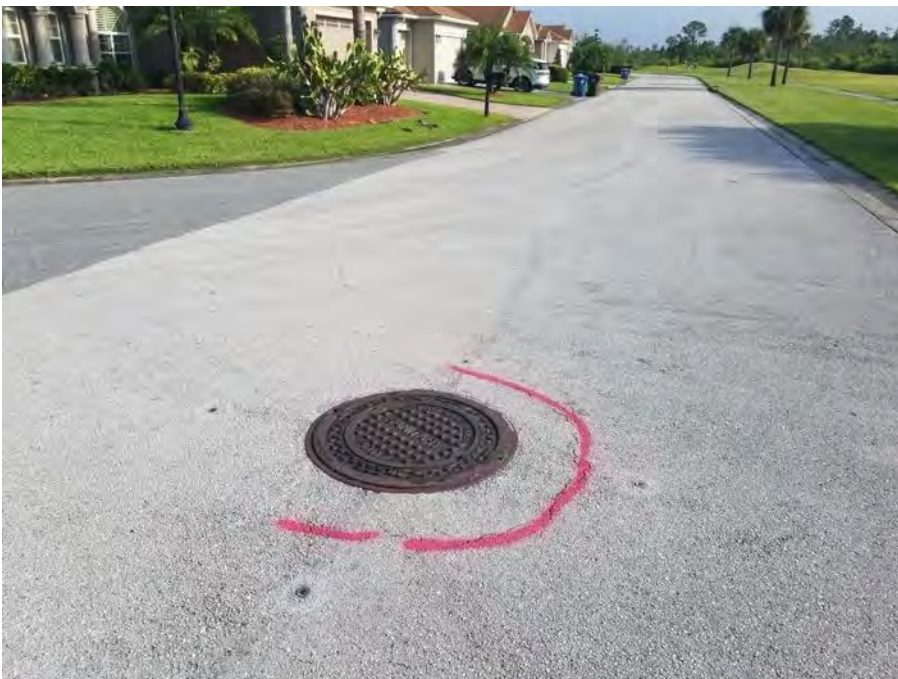
Exhibit 12D

| Defects | Address | Curbline | | | Pavement | Function Impaired | Exhibit |
|---|---|---|---|---|---|---|---|
| 275 | Intersection of McArthur Palms Drive and Ashton Palms Drive | - | - | | Reflective cracking at manhole. | No | 12D |
