# Lake Ashton Community Development District

## Curblin and Pavement Assessment Report

November 17, 2020

PROJECT NAME: Lake Ashton CDD Pavement and Curb Assessment  
RES PROJECT #: 19-165

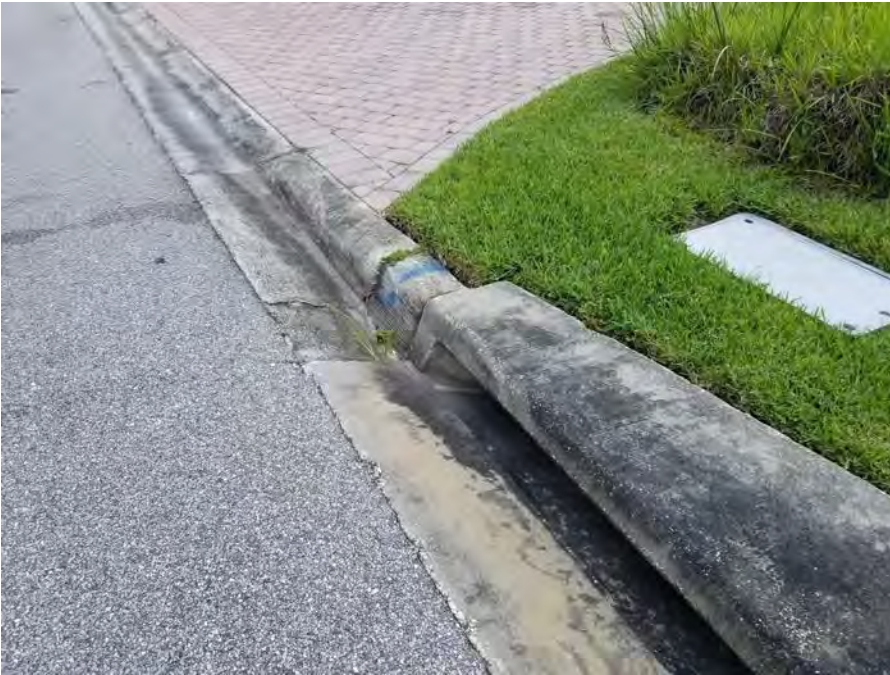
Exhibit 16A

| Defects | Address | Curbline | | | Pavement | Function Impaired | Exhibit |
|---|---|---|---|---|---|---|---|
| 16 | 4185 Dunmore Dr. | Yes | No | Broken curb present at inlet throat. | | No | 16A |

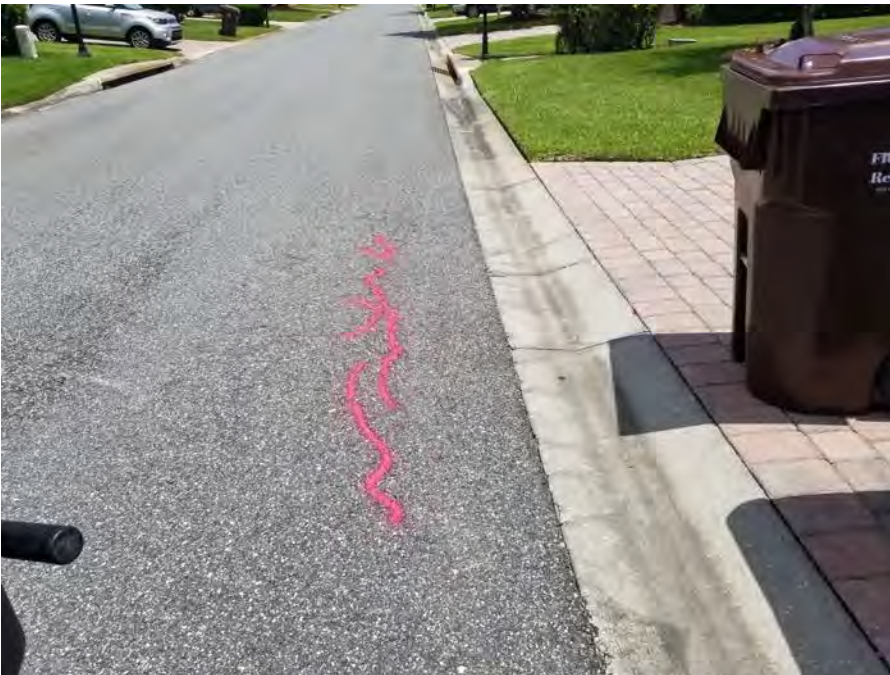
Exhibit 30A

| Defects | Address | Curbline | | | Pavement | Function Impaired | Exhibit |
|---|---|---|---|---|---|---|---|
| 29 | 4089 Dunmore Drive | - | - | | Alligator cracking present | - | 30A |

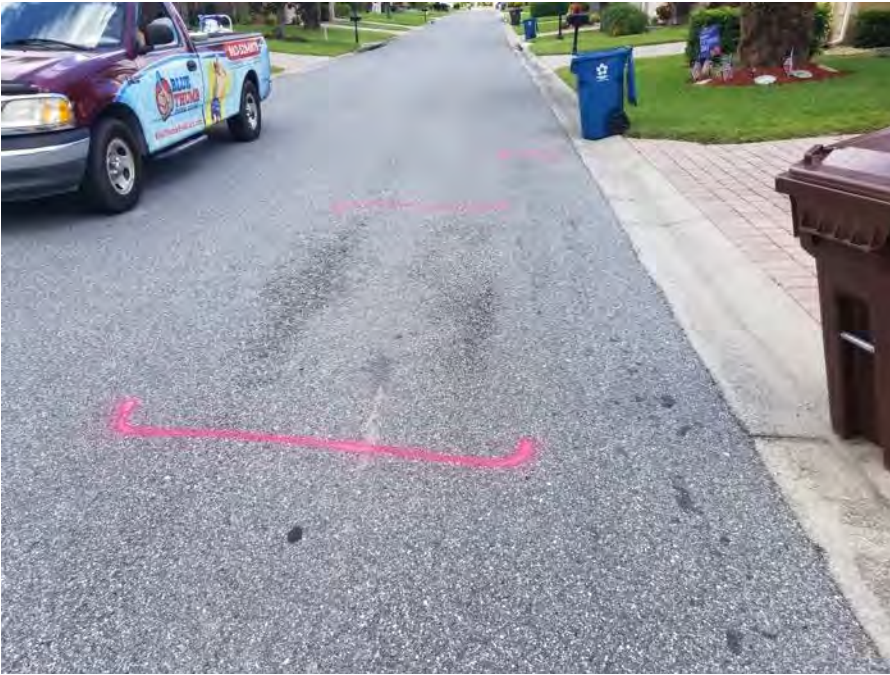
Exhibit 35A

| Defects | Address | Curbline | | | Pavement | Function Impaired | Exhibit |
|---|---|---|---|---|---|---|---|
| 34 | 4057 Dunmore Drive | - | - | | Spalling present in pavement. | No | 35A |

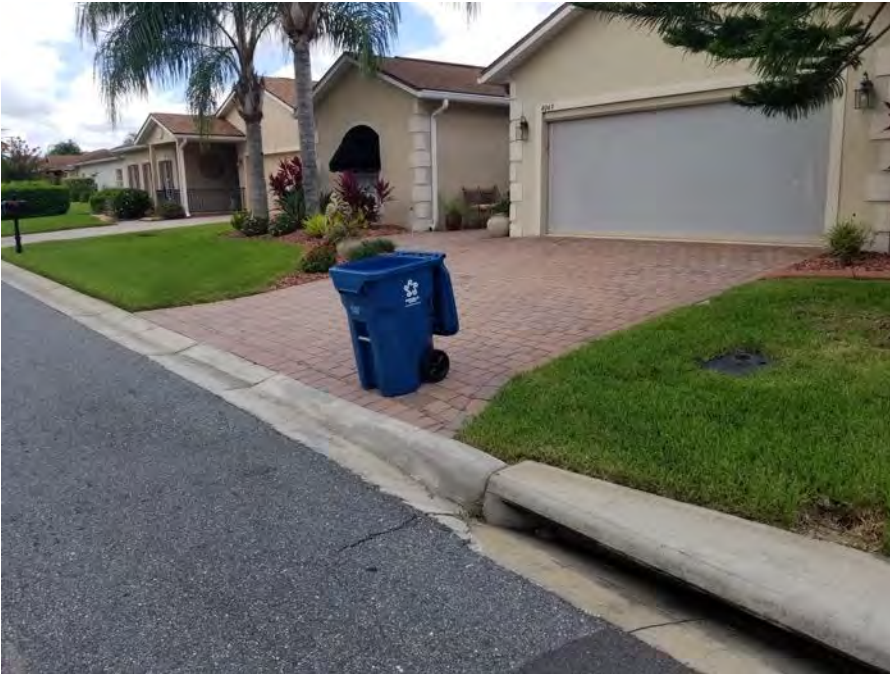
Exhibit 37A

| Defects | Address | Curbline | | | Pavement | Function Impaired | Exhibit |
|---|---|---|---|---|---|---|---|
| 36 | 4049 Dunmore Drive | Yes | - | Broken gutter and asphalt at inlet. | | No | 37A |
